EXHIBIT B

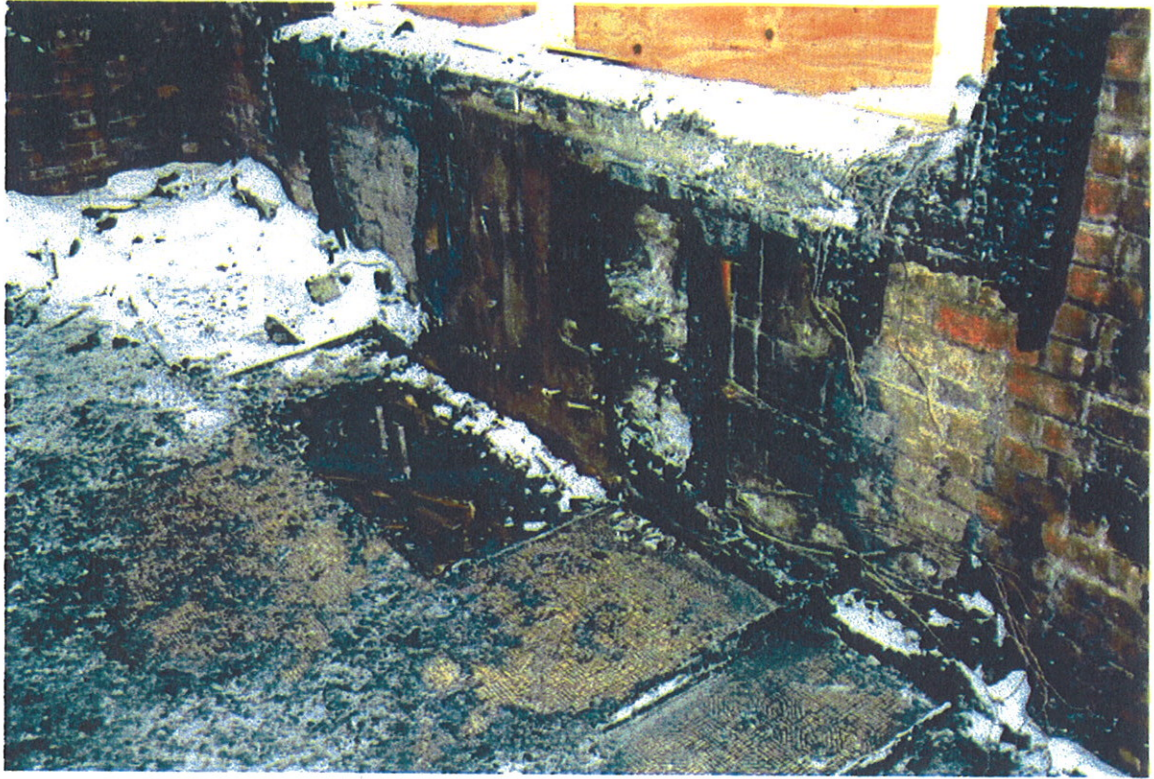
Photo 13: Openings in base cabinet (removed) and combustible wall exposed the polyethylene vapor barrier, PVC drain pipe and access to the “balloon construction-like” wood framing.

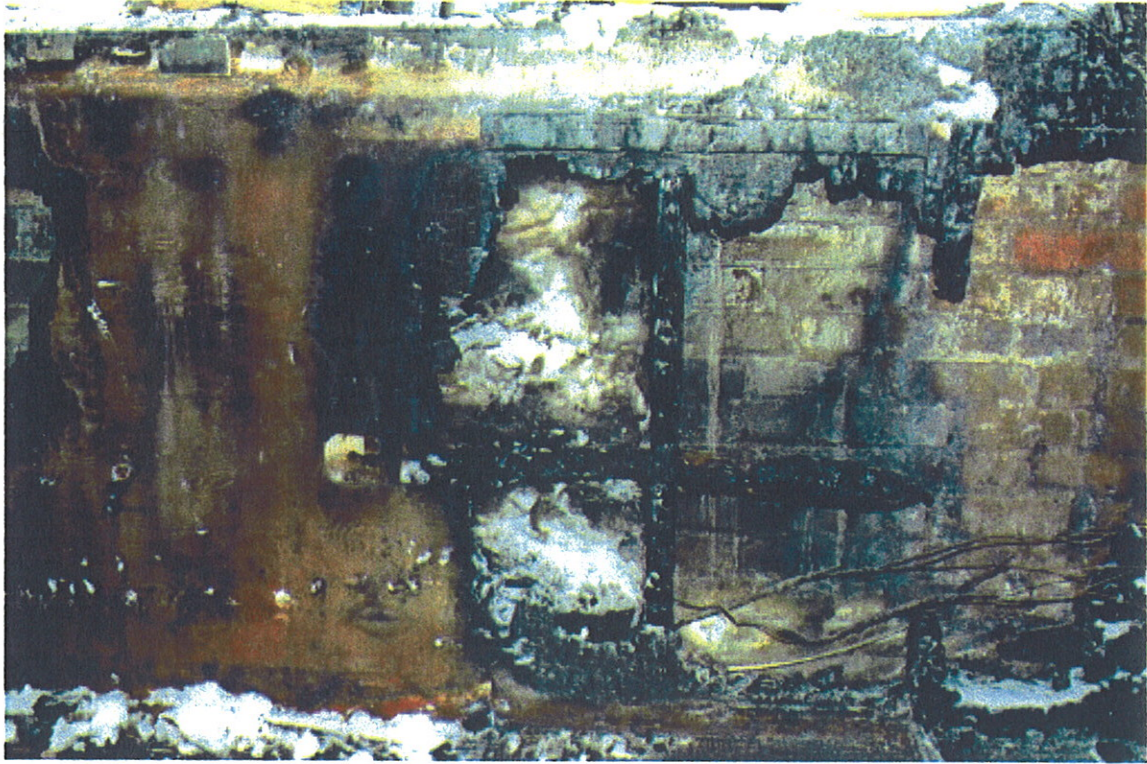
Photo 14: After the sink cabinet was removed, initial directional fire spread indicators were present on the PVC drain pipe and wood members of the wall.
